Manhole Inspection Summary

Manhole # S45GG_060MH

Record Plat: **45GG** Node: **060** Status: **Found**

Insp Date: **8/14/08 11:21 AM**

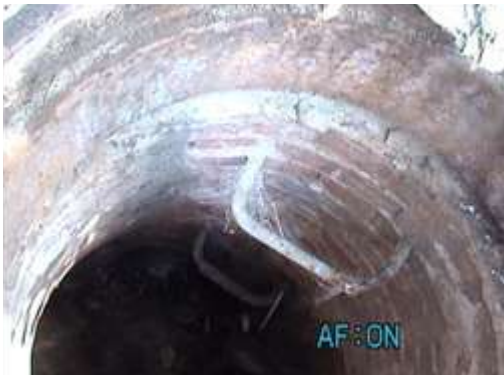
Defect 1

Frame Offset: **1** (in.) Condition: ☐ Sound ☐ Cracked ☒ **Leaks**

Frame leaks

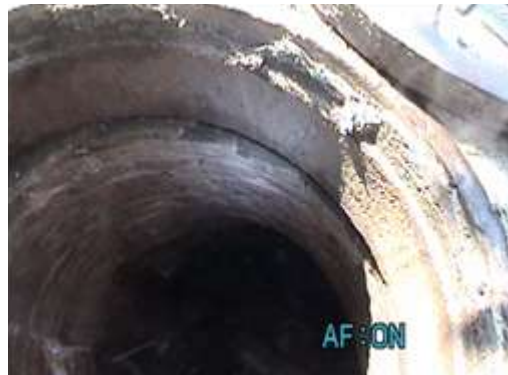
Defect 2

Infiltration: ☐ None ☒ **Joint** ☐ Cracks ☒ **Mortar** ☐ Roots ☒ **Wall**

Infiltration

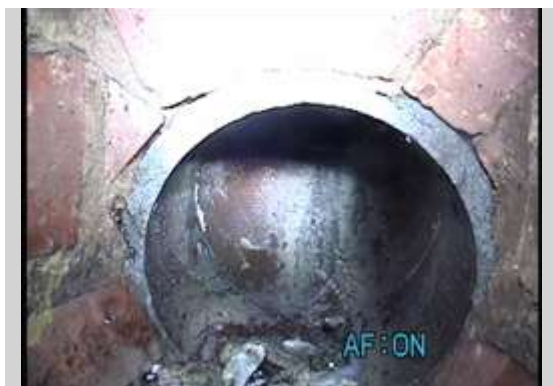
12 O'Clock Outflow

Pipe Height: **8.4** (in.) Rod and Bar (Angled)
Pipe Material: **Clay** ☐ Pipe Lined
Invert Depth: **10.10** (ft.) Flow Characteristics: **Slow**
Deposits: ☐ None ☐ Mud ☐ Sludge ☒ **Debris** ☐ Grease
Silt Depth: **0.15** (in.) Deposits Extent: **Light**
Infiltration: **None** Pipe Seal Cond: **Sound**

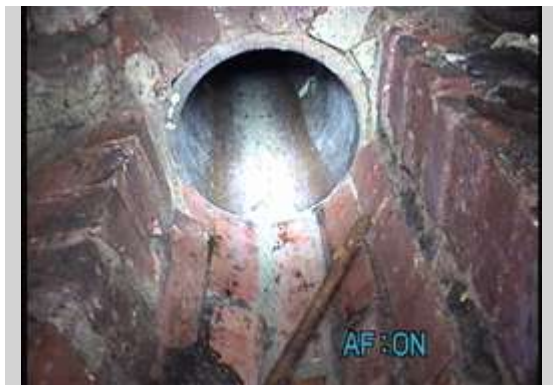
3 O'Clock Inflow

Pipe Height: **8.4** (in.) Rod and Bar (Angled)
Pipe Material: **Clay** ☐ Pipe Lined
Invert Depth: **9.80** (ft.) Flow Characteristics: **Slow**
Deposits: ☒ **None** ☐ Mud ☐ Sludge ☐ Debris ☐ Grease
Silt Depth: (in.) Deposits Extent:
Infiltration: **None** Pipe Seal Cond: **Sound**

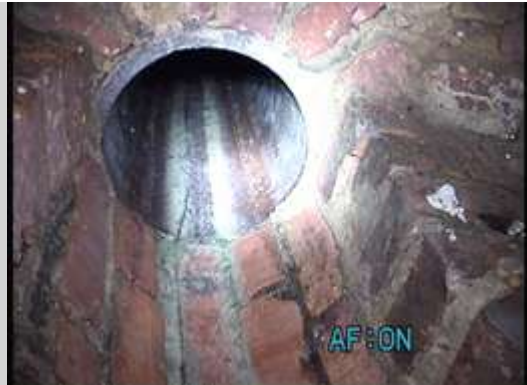
9 O'Clock Inflow

Infiltration: **None** Pipe Seal Cond: **Sound**
